January 29, 2021

RE: Safety Review of Camp Meeting Road
Citizens for a Great School / Quaker Valley High School Relocation
Leet Township, Allegheny County, Pennsylvania

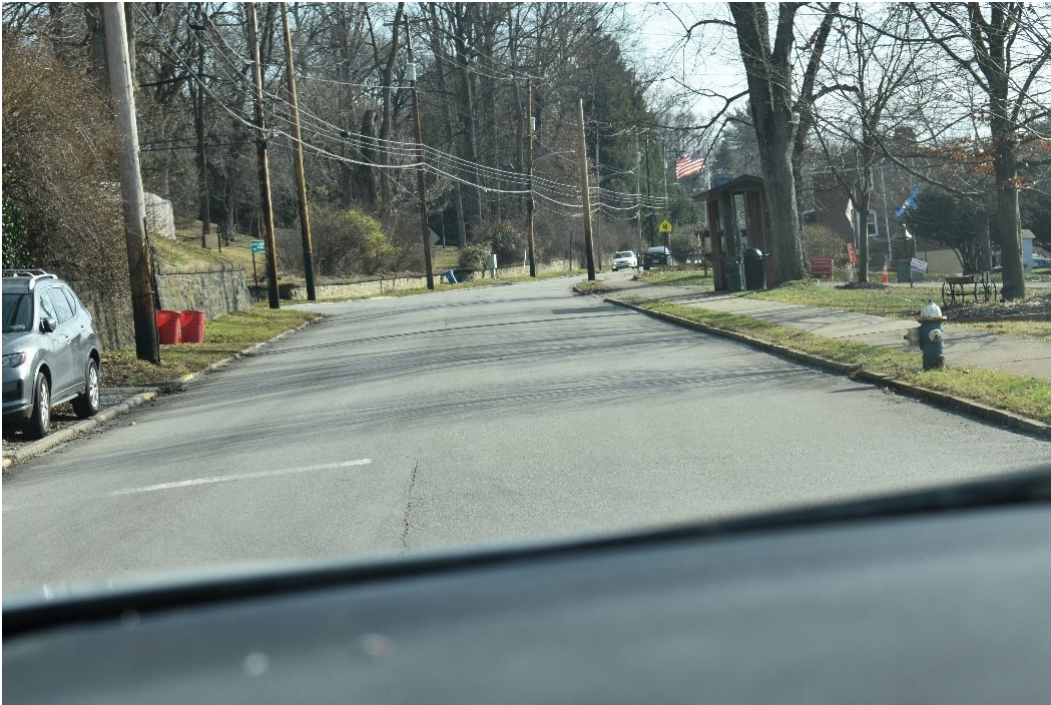
- A. Restricted sight distance looking right from Camp Meeting Road at Beaver Street due to a wall and utility pole in the northwestern corner. This leads to an increased risk that a motorist on Camp Meeting Road will pull out in front of a motorist heading eastbound on Beaver Street, resulting in an angle collision.

View of Camp Meeting Road from eastbound Beaver Street. As can be seen, all but the last few feet are hidden by the wall and utility pole. This photo also shows the lack of pavement markings on Beaver Street in the Camp Meeting Road intersection.

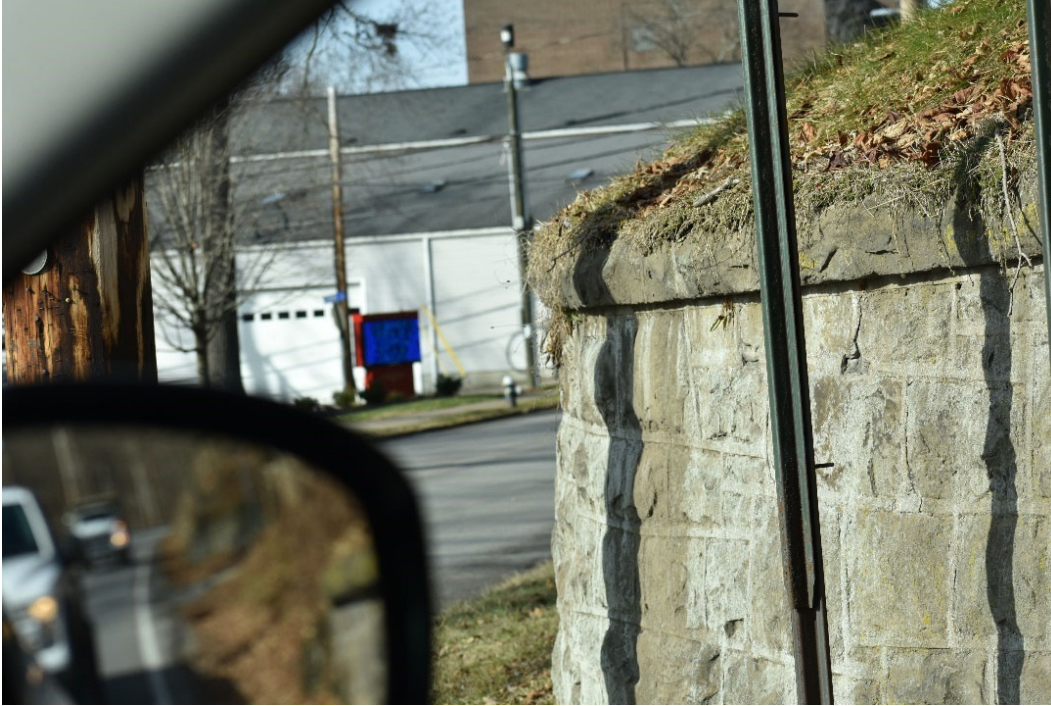
View looking right from Camp Meeting Road from the perspective of a vehicle stopped at the stop sign. The stop sign is well behind the wall lining Beaver Street.

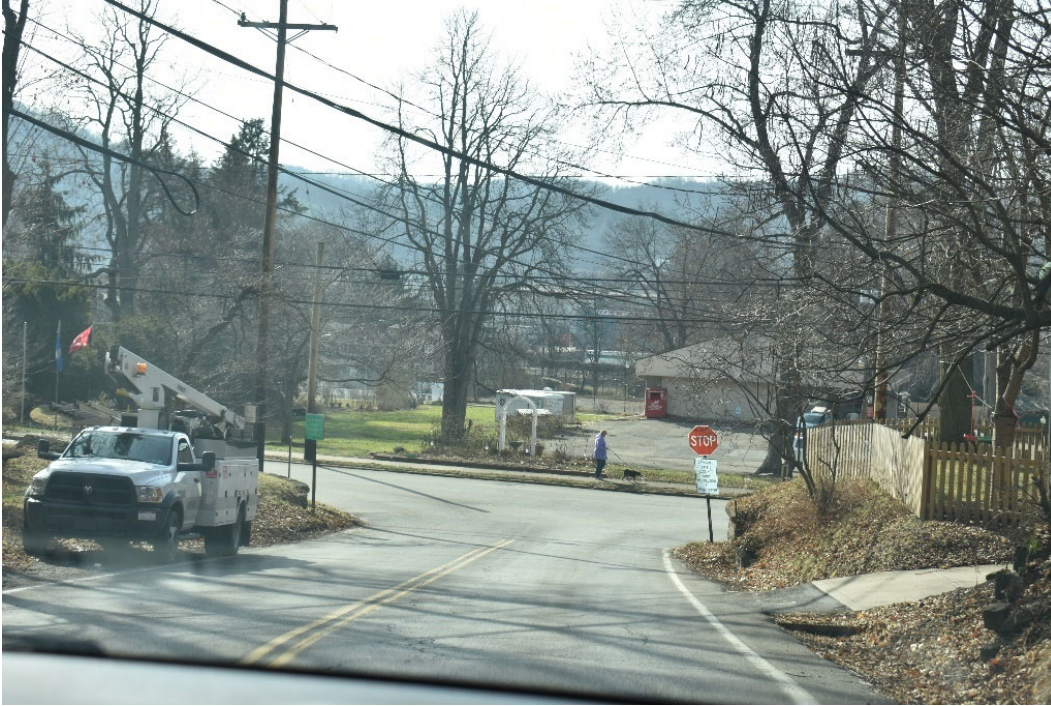
- B. General difficulty pulling out of Camp Meeting Road at Beaver Street due to cross traffic, the three-way stop to west, and the VFW parking lot. This could lead to vehicles pulling out in front of traffic on Beaver Street, either due to confusion or risk-taking behavior caused the lack of acceptable gaps in Beaver Street traffic. The consequences of such actions are typically angle collisions in the intersection.

The stop sign has a supplemental sign indicating “OPPOSING TRAFFIC DOES NOT STOP USE CAUTION AT INTERSECTION”.

During the field view, the driver also experienced difficulty in finding a gap in Beaver Street traffic due to overall congestion conditions. It is anticipated that this will be identified and addressed in the traffic study being conducted by the school district. It is expected that alternative traffic control (i.e., signalization, all-way stop, etc) will be evaluated and proposed by the traffic study.

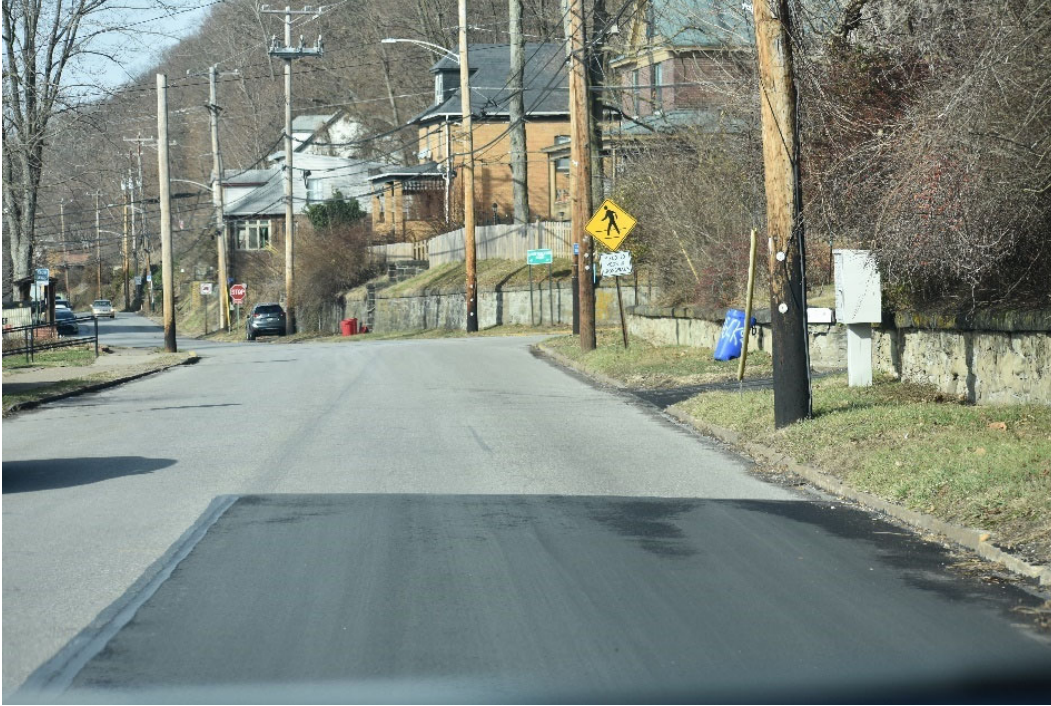
There is a slight skew (<10 degrees) in Beaver Street near the Camp Meeting Road intersection. Westbound traffic must turn to the left to continue following the Beaver Street alignment. Eastbound traffic must turn to the right. If a westbound driver fails to make the turn, they will hit the wall and utility pole in the northwest quadrant. (see photo below). Skewed intersections are generally undesirable because they complicate driver tasks such as navigating the intersection and identifying gaps in traffic into which to turn.

Photo shows skew in Beaver Street at its intersection with Camp Meeting Road. It also shows the lack of pavement markings.

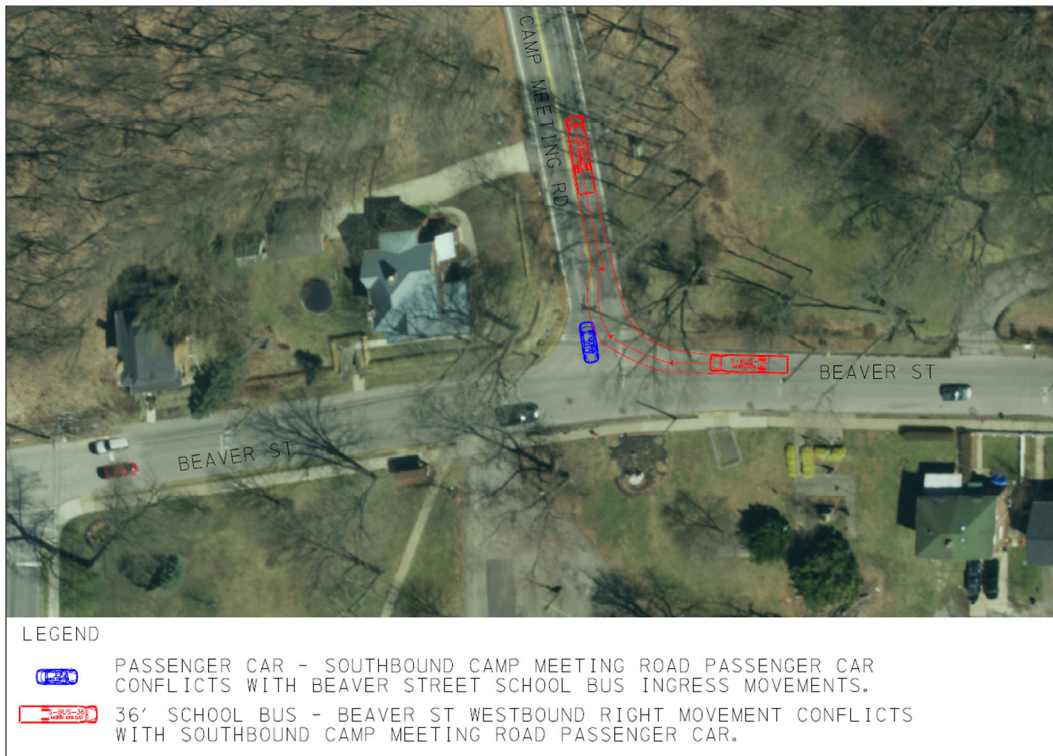
The two figures below show school buses turning in and out of Camp Meeting Road from each direction of Beaver Street with a vehicle waiting on Camp Meeting Road attempting to turn out. This illustrates the tight radii on each corner, as well as how the sight obstructions caused by the wall and utility pole in the northwestern quadrant greatly reduce what limited room is available in the intersection for turning. The consequences of the poor turning radii include the potential for buses to hit the obstructions in the corner while turning, or to hit other vehicles in

the intersection because the buses are forced into opposing traffic lanes while turning around the obstructions in the corner.

Turning simulation showing the school bus turning right into Camp Meeting Road

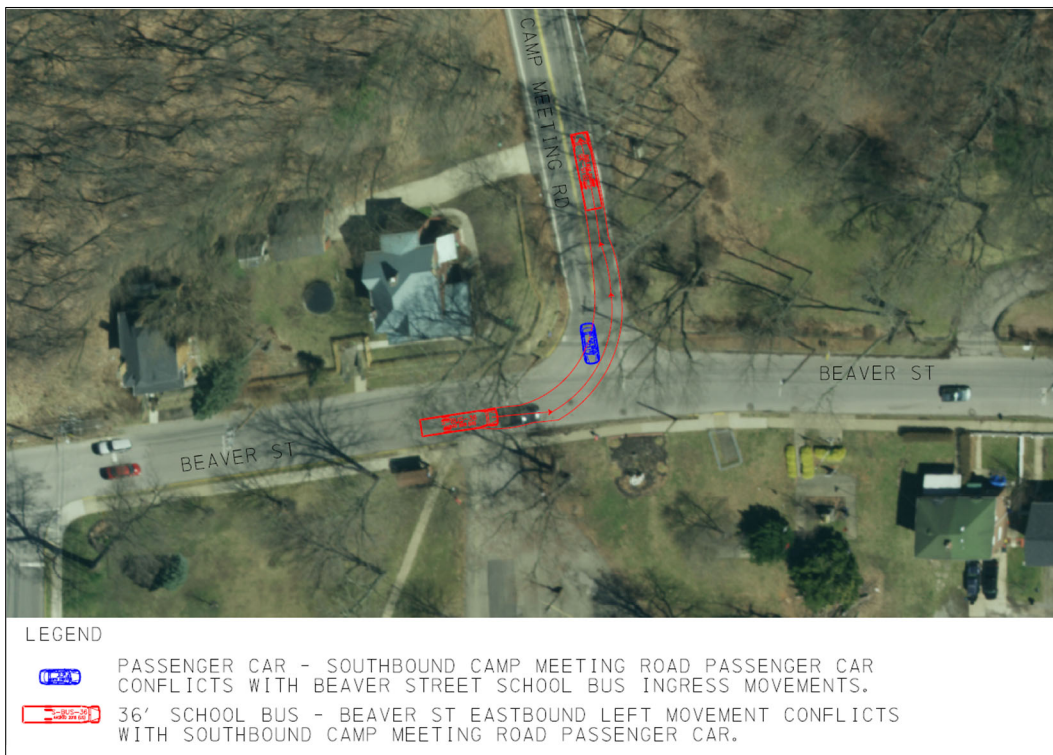
Turning simulation showing the school bus turning left into Camp Meeting Road

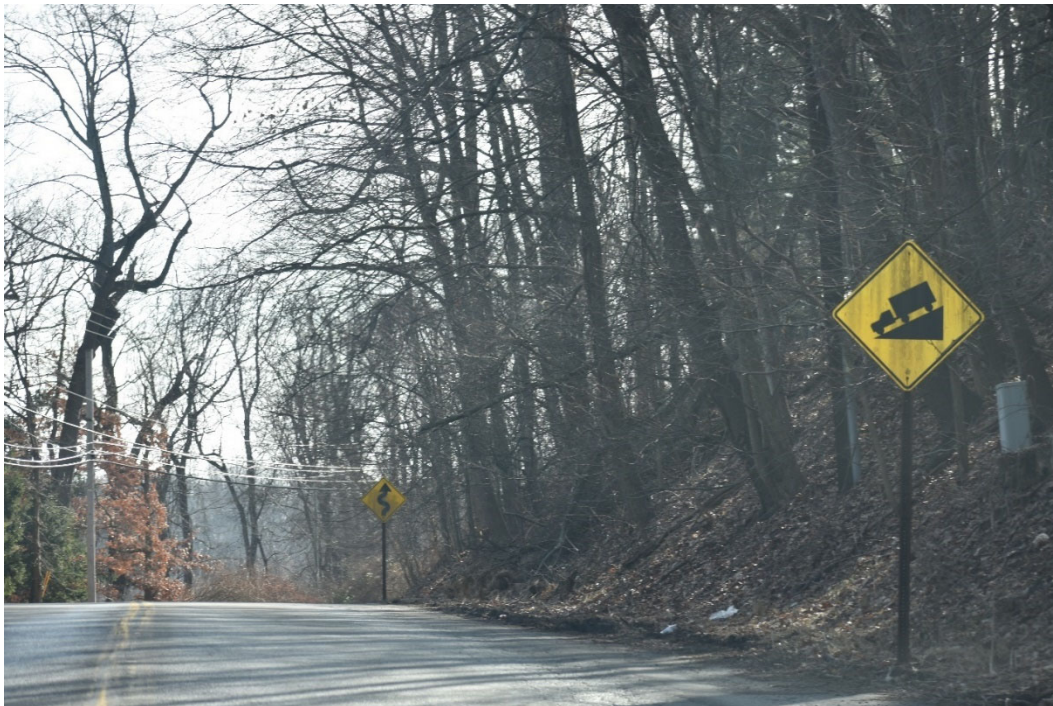
The grade on Camp Meeting Road between the proposed high school driveway and Beaver Street was estimated at 10% using measurements and tools in Google Earth. This would be considered a steep roadway by most highway standards. Downgrades increase braking distance, speeding, and difficulty stopping and slowing in poor weather conditions. The consequences include an increased risk of hitting fixed objects in the roadside or hitting other vehicles on Camp Meeting Road. Downgrades can also increase the likelihood of sliding off of sharp horizontal curves, which the corridor has many. The following photo shows the W7-1 “hill” sign installed on Camp Meeting Road, which is warranted in the Manual on Uniform Traffic Control Devices (MUTCD) based on the steepness and length of the grade. According the MUTCD, this sign *should be used in advance of a downgrade where the length, percent of grade, horizontal curvature, and/or other physical features require special precautions on the part of road users.*

Hill (W7-1) and Winding Road (W-15) signs on southbound Camp Meeting Road approaching the school area

Note the W-15 “winding road” sign that has also been installed. This sign is correctly applied and is warranted when there are three or more changes in roadway alignment each separated by a tangent distance of less than 600 feet.

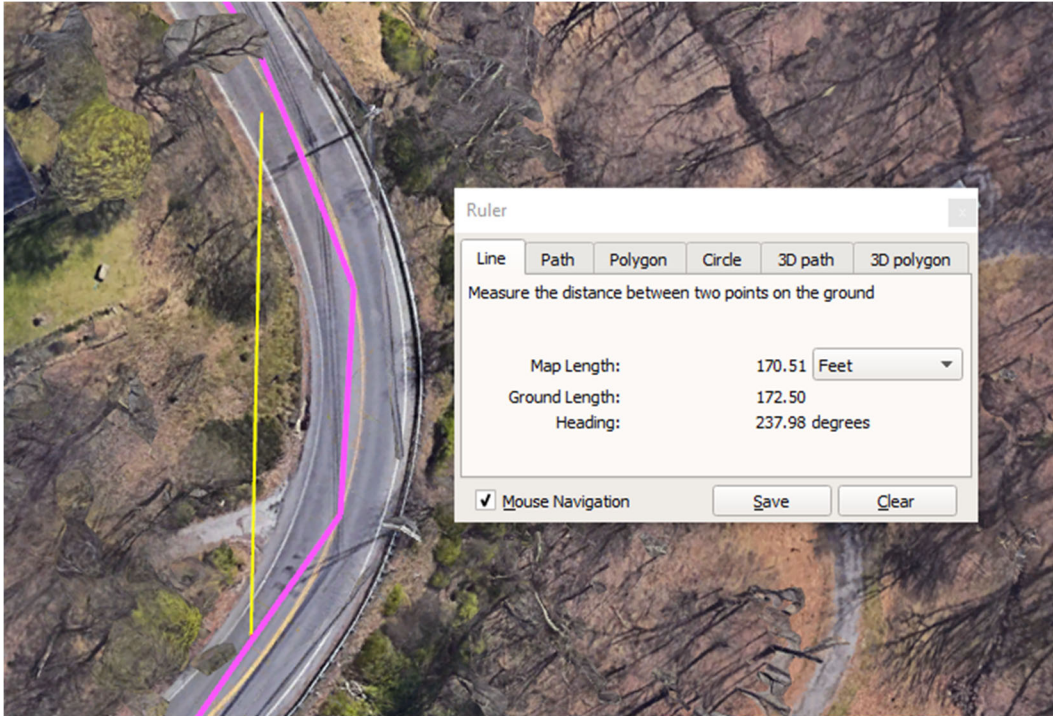
There are multiple examples along Camp Meeting Road where these minimums are not met because of embankments and / or vegetation on the inside of horizontal curves obstructing visibility. The consequences of inadequate sight distance are an increased risk of hitting objects in the road, including other vehicles, such as those that might be moving slow or queued due to congestion.

Measured length of 170-ft blocked by embankment that is located at the edge of road on the inside of the curve.

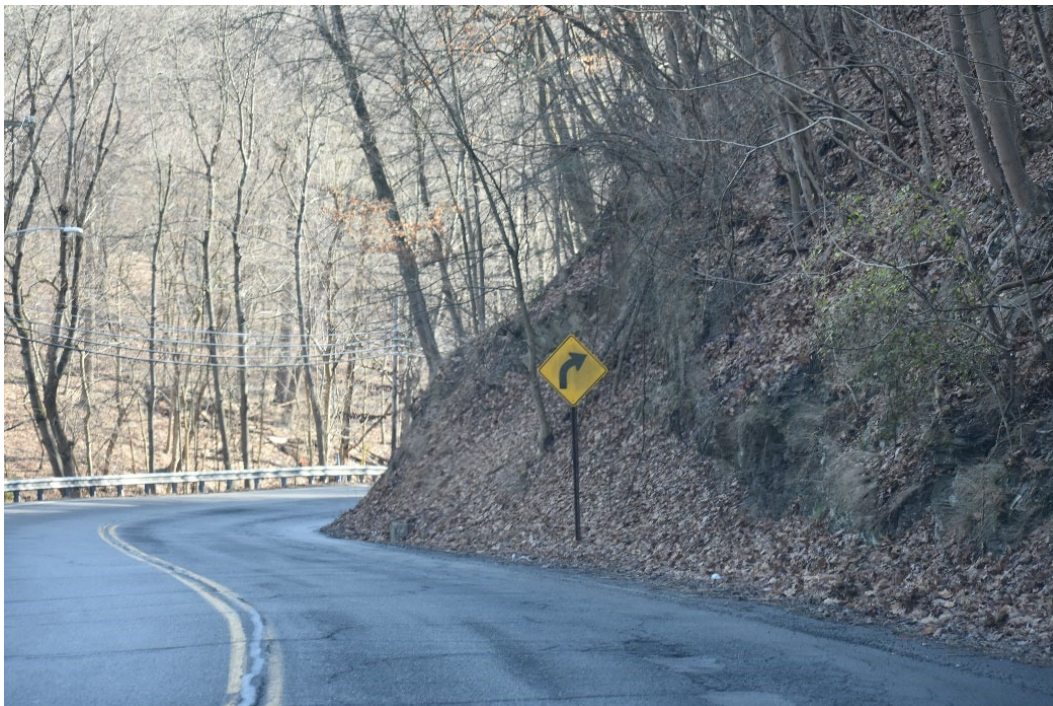
Sight distance in horizontal curve approximately 1200-ft from Beaver Street

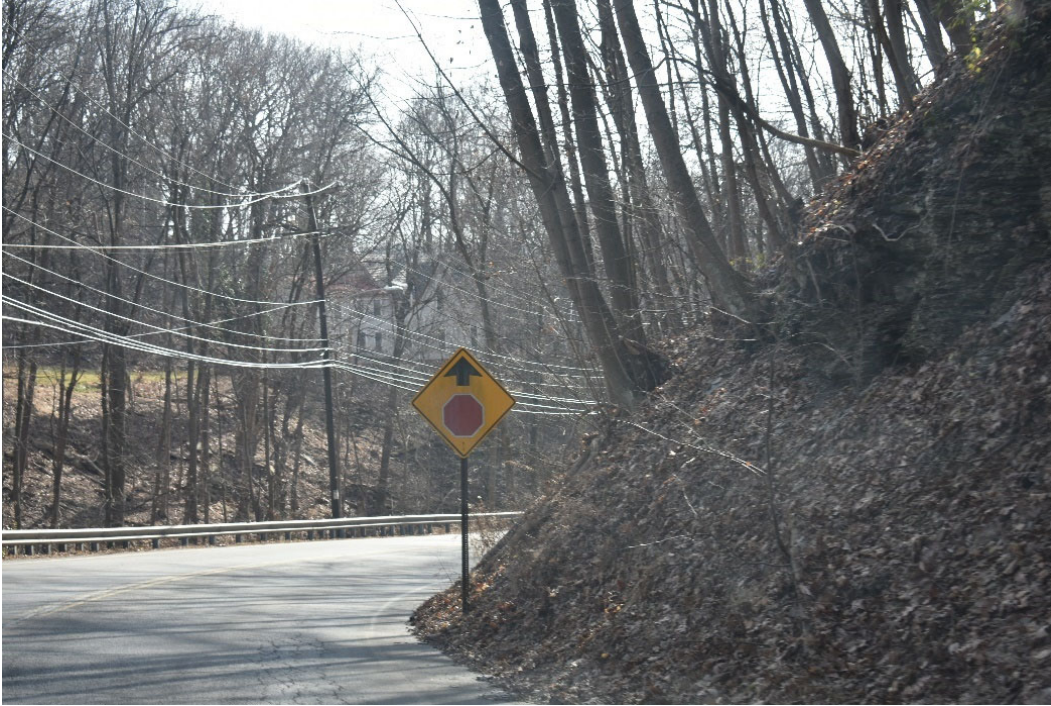
Sight distance in horizontal curve approaching stop sign at Beaver Street

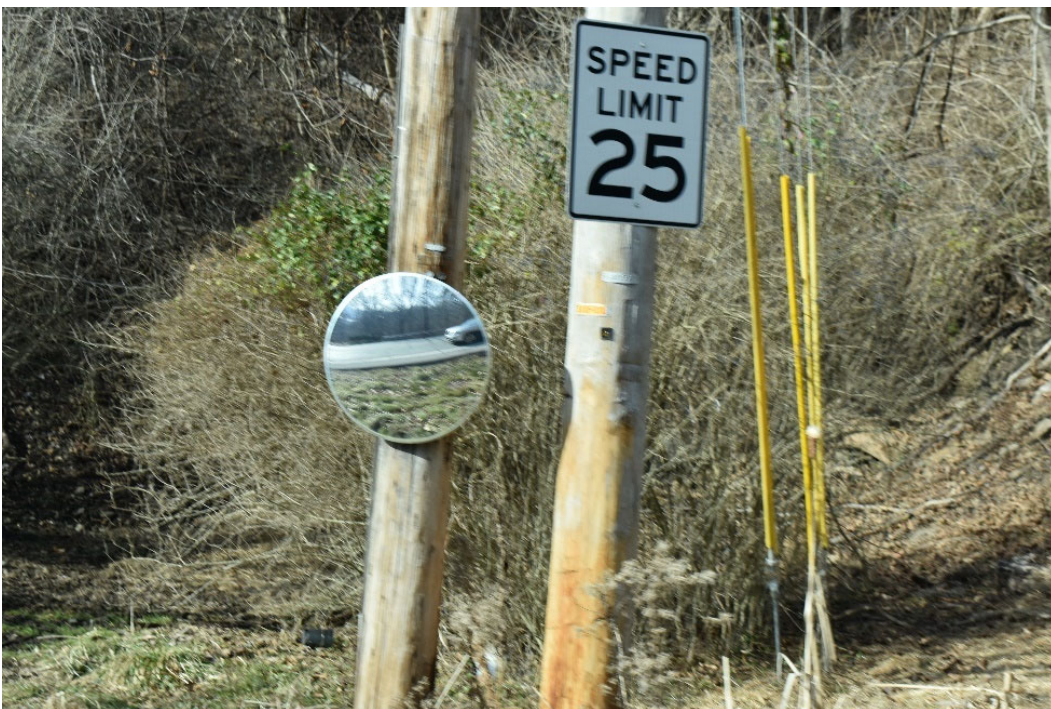
In addition, a driveway on a horizontal curve was observed with a mirror across the road to assist with sight distance. The following photo shows this mirror. PennDOT policy generally discourages the use of mirrors and will only allow them if there are no other practical alternatives for improving the sight distance or providing an alternate method of traffic control. They are a last resort for sight distance problems and should be considered atypical.

Mirror at a driveway along Camp Meeting Road due to poor sight distance

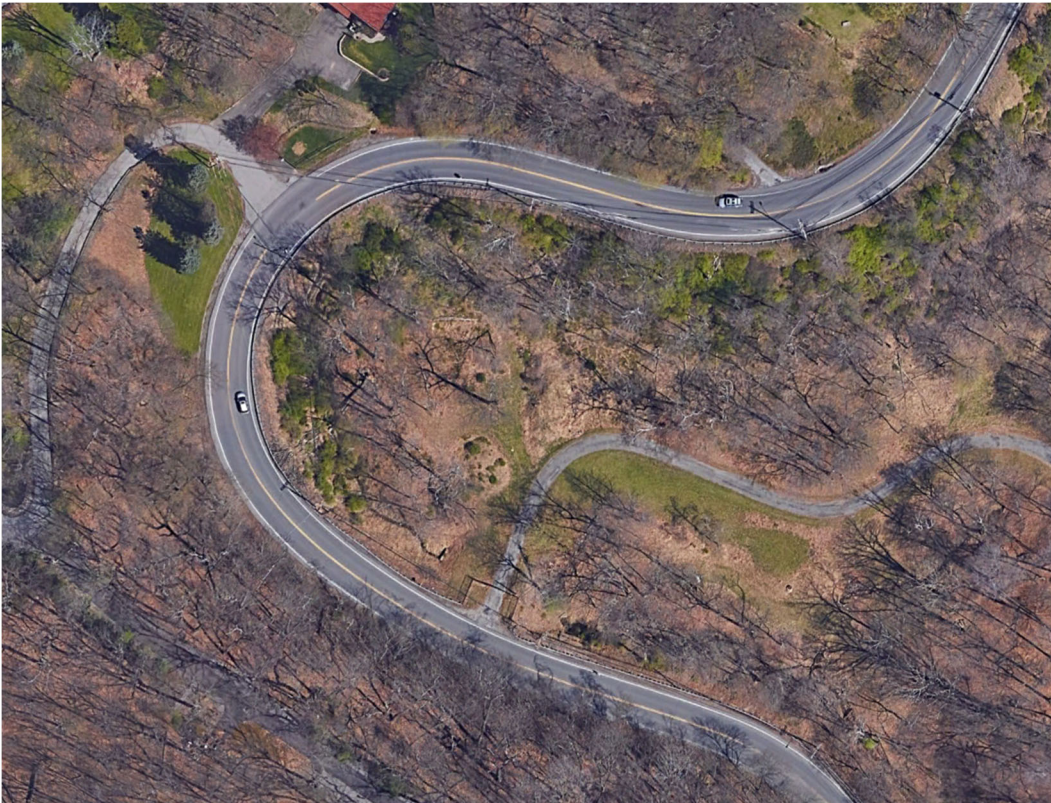
Camp Meeting Road has a series of reverse and broken back horizontal curves between the proposed school site and Beaver Street. The curves are of such frequency and spacing that the winding road sign is warranted and installed in both directions, as noted previously. In addition, one curve of particular concern is the curve with the intersection of Myrtle Hill Road. This curve has the “hairpin curve” (W1-11) sign installed because the MUTCD indicates it can be applied when *the curve has a change in horizontal alignment of 135 degrees or more*. In this case, the change in horizontal alignment is approaching 180 degrees, as shown in the following aerial photograph. Horizontal curves carry increased risk of sliding off the road or rolling over. A series of horizontal curves increase demands on the driver. Reverse curves complicate efforts to provide proper superelevation around curves, especially at the entrances to the curves. Substandard superelevation makes the curves even more susceptible to run off the road crashes.

Curve with “Hairpin Curve” (W1-11) sign installed

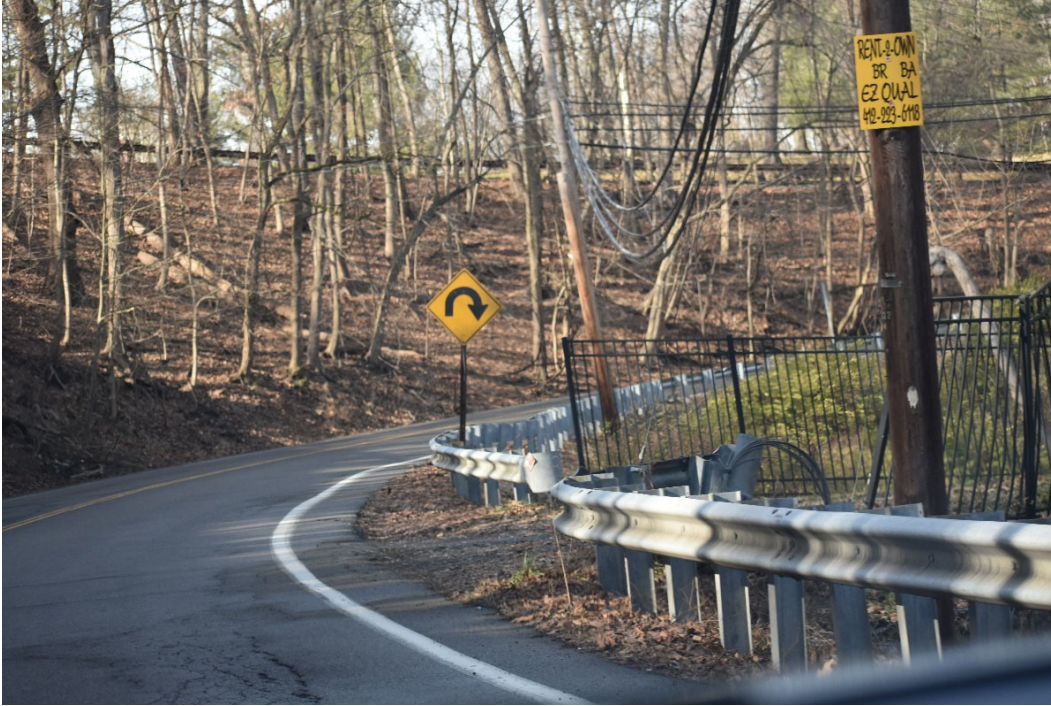
"Hairpin Curve" sign (W1-11) in the northbound direction. A second sign is installed southbound.

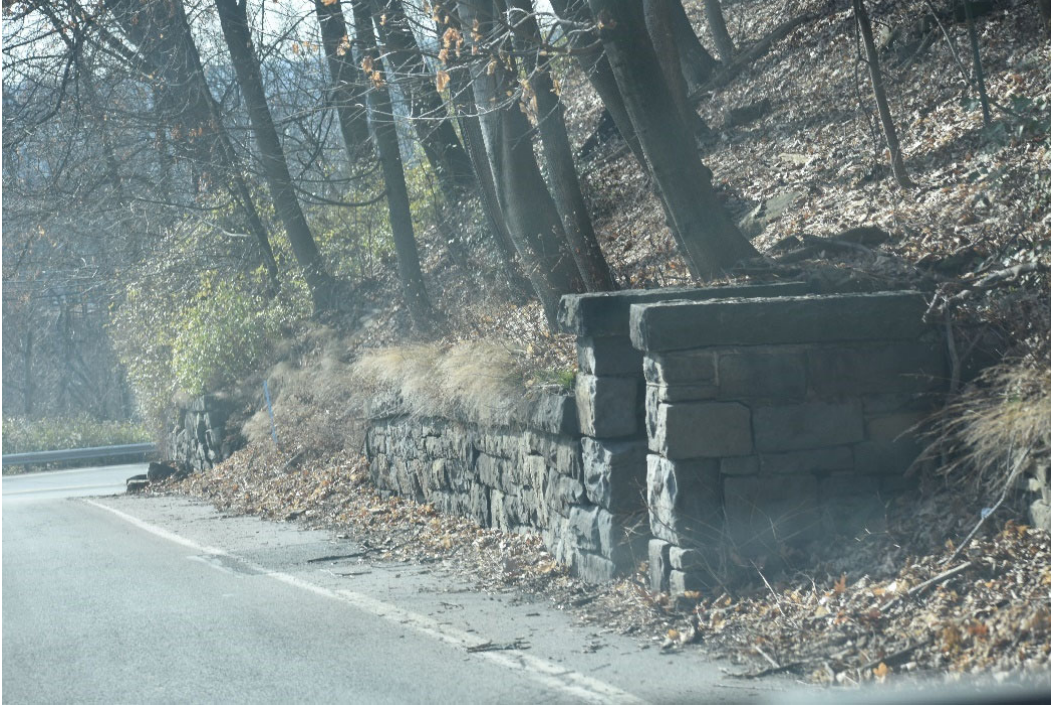
Blunt end of a retaining wall sitting at the back of the shoulder, only a couple of feet from the travel lane. In addition, in the background, pieces from the wall can be seen laying on the shoulder. Blunt fixed objects can lead to high deceleration in the crash and / or spearing of the vehicle, the consequences of which are more severe crashes.

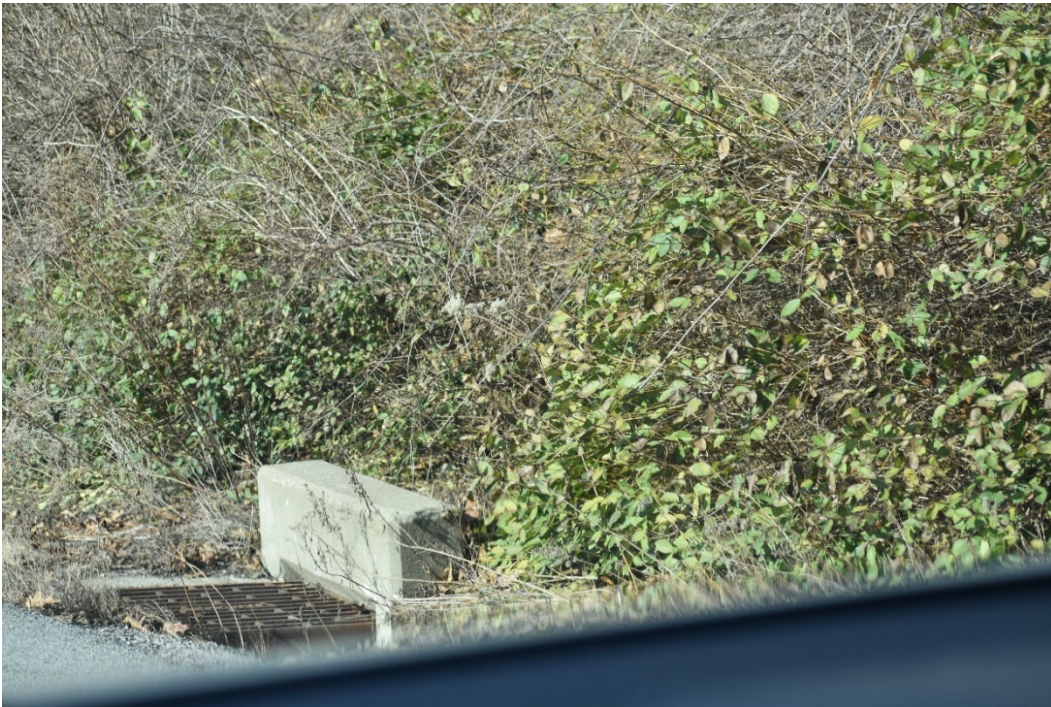
Headwall of an inlet that presents a blunt end fixed object hazard. In addition, some of the inlets have broken or depressed grates / sidewalls that could grab a tire, thus increasing the potential severity of the crash.

- Inlets – We estimate that replacing one of the older style inlets will cost approximately \$7,500 each. A quick investigation revealed at least six of these inlets, which amounts to a total of \$45,000.

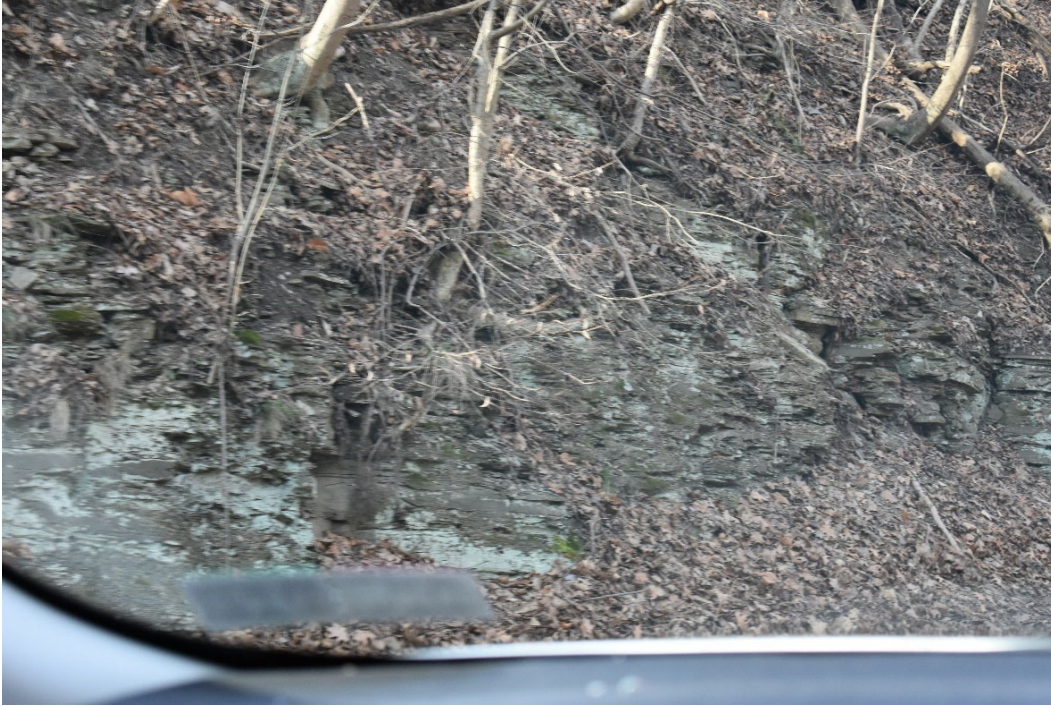
One example of a rock outcropping that presents a fixed object hazard. PennDOT Design Manual 2, Chapter 12, indicates *a steep, rough-sided rock cut should normally begin outside the clear zone or be shielded. A rock cut is normally considered to be rough-sided when the face can cause excessive vehicle snagging rather than provide relatively smooth redirection.*

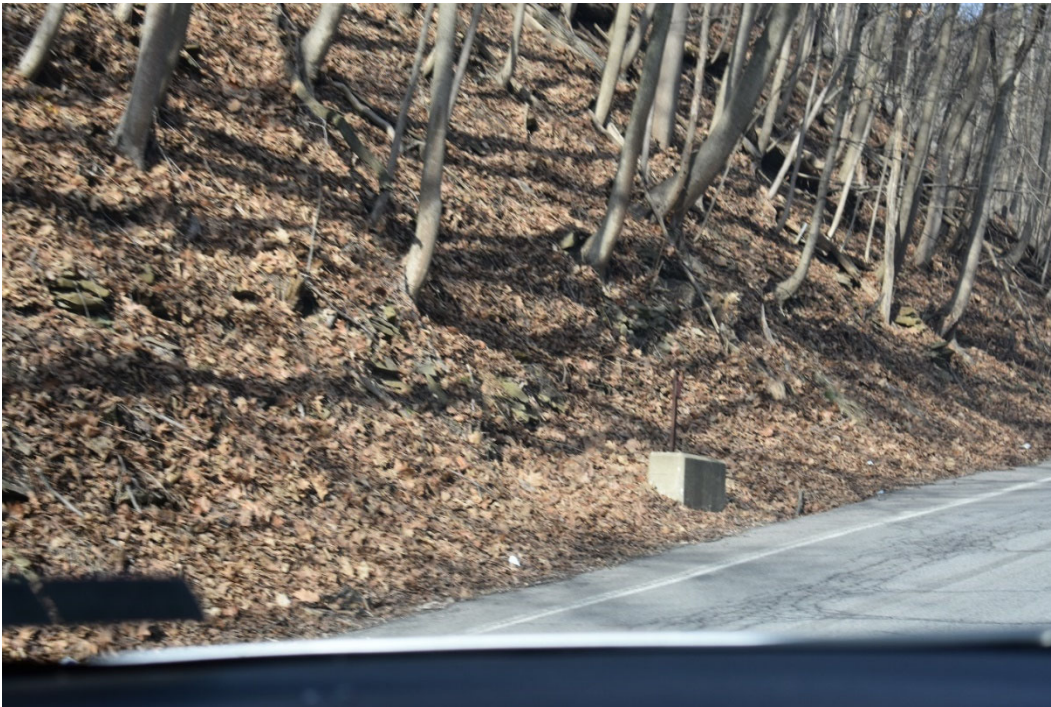
Trees greater than 4" in diameter are considered fixed object hazards. Steep embankments can cause rollover crashes or fixed object crashes. The photo also shows another inlet headwall protruding prominently from the earth around it.

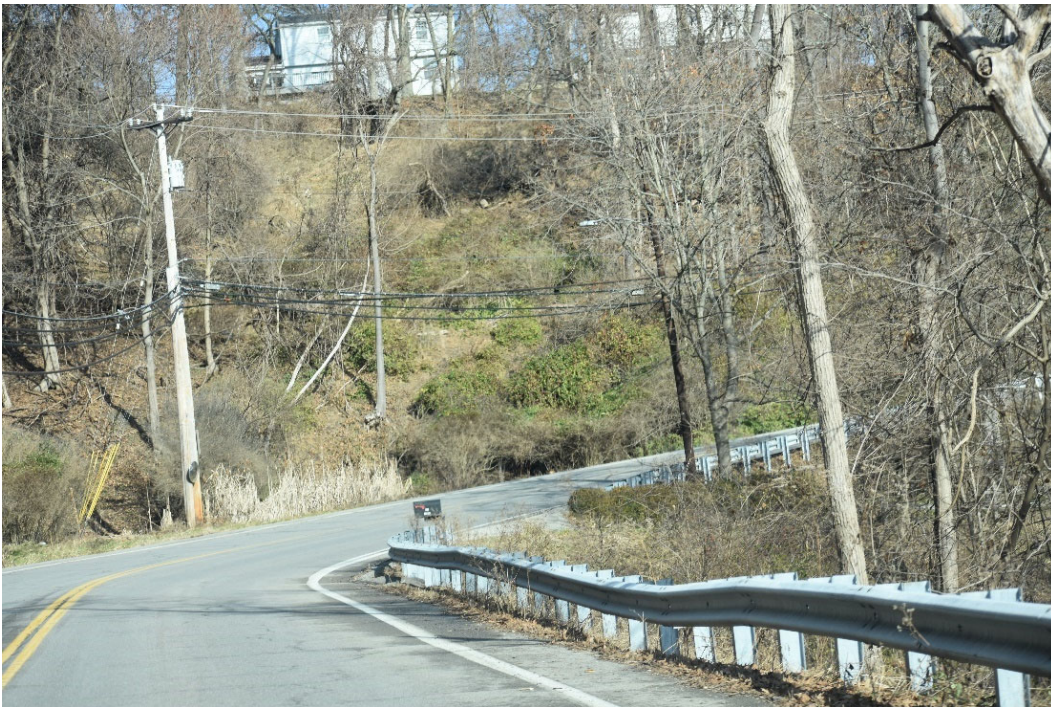
With respect to sliding guide rail, it should be noted that there should be 2-ft of somewhat level earth behind the guide rail posts to secure them in the ground. This is not likely to be present throughout, especially if the posts are sliding.

Photo shows sliding guide rail, likely due to earth sliding behind it.

- Guide rail – Typical guide rail costs approximately \$25 per linear foot, with end treatments estimated at \$3,500 each. Guide rail currently runs along the eastern side of Camp Meeting for nearly all of the length between Beaver Street and proposed school. Replacing this guide rail would cost approximately \$50,000 (includes end treatments). This also gives an idea of what it might cost to add guide rail at select locations on the other side of the roadway, acknowledging that hazards on the other side of the roadway would likely most be dealt with by removing them.

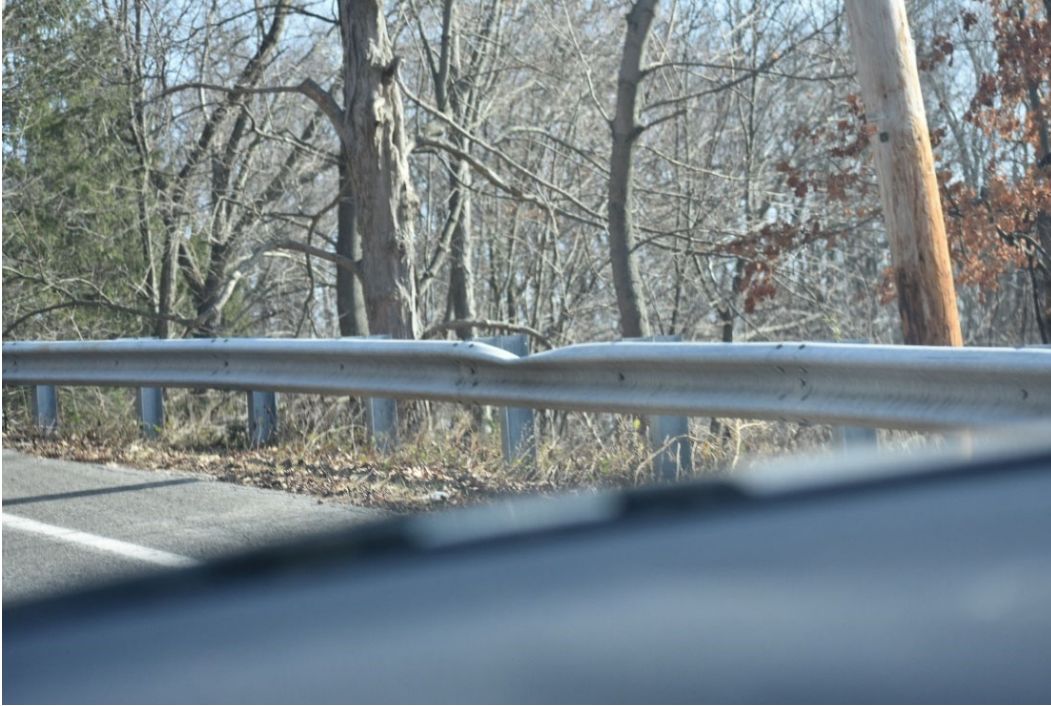
In addition, there should be a clear area behind the guide rail posts that is at least equal to the deflection distance of the guide rail. Without a detailed examination, of the guide rail, it will not be possible to know the deflection distance. According to the PennDOT Roadside Safety Pocket Guide, deflection distances range from 1.5-ft to 9-ft. It is likely that there are obstructions, namely utility poles and trees, within the deflection distance of the guide rail that has been installed.

Damaged guide rail. Also, potential fixed object hazards behind the guide rail within the deflection distance.

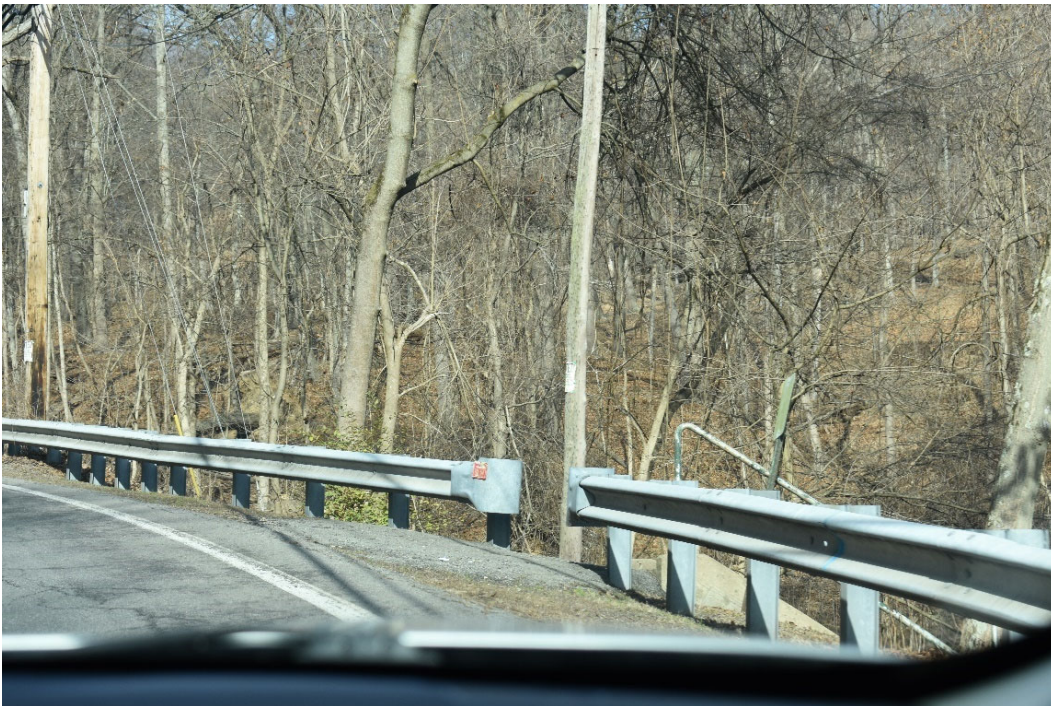
Earth around guide rail posts is eroding away from the posts in the background of the photo.
