January 29, 2021

RE: Safety Review of Camp Meeting Road
Citizens for a Great School / Quaker Valley High School Relocation
Leet Township, Allegheny County, Pennsylvania

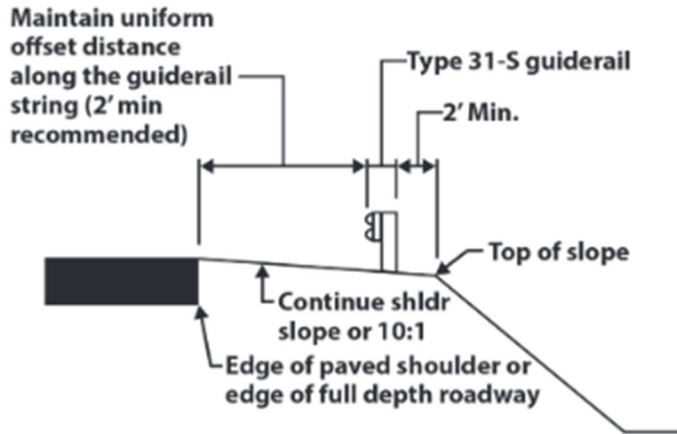
Excerpt from PennDOT Roadside Safety Pocket Guide showing 2-ft minimum distance between the back of the guide rail post and the top of slope on embankments.
